MPS GH2 Flow Control Valve Poppet Failure Investigation Summary

Space Shuttle Main Propulsion System Gaseous Hydrogen Flow Control Valve Poppet Failure

Presenter: Rick Zeitler
United Space Alliance
Subsystem Area Manager APU/HYD/MPS
321 861 3123

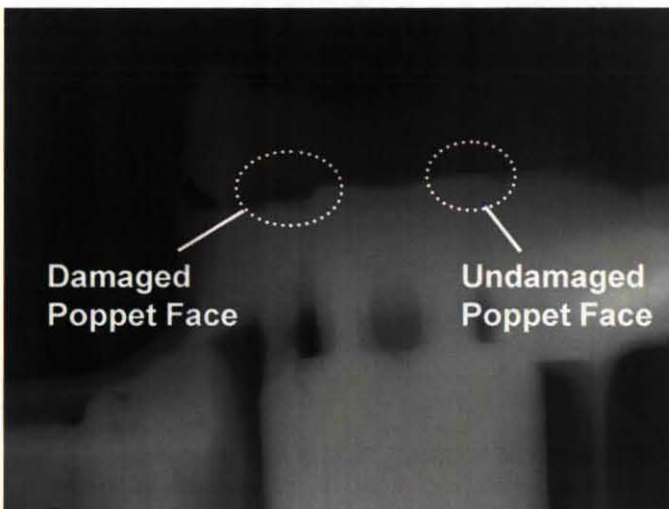
FCV #2 On-Vehicle X-Ray

- Post flight X-ray inspections of FCV #2 (LV57) were performed on the vehicle, and revealed damage to the solenoid poppet nose
 - Missing section of material (~ 20% of circumference) was detectable
- LV57 (S/N 1005) removed from the vehicle and shipped to the vendor (Vacco) for disassembly prior to failure analysis at HB
 - Damaged poppet obvious upon removal, confirming X-ray indications
 - Damaged area was aligned with valve inlet tube (significance not known)

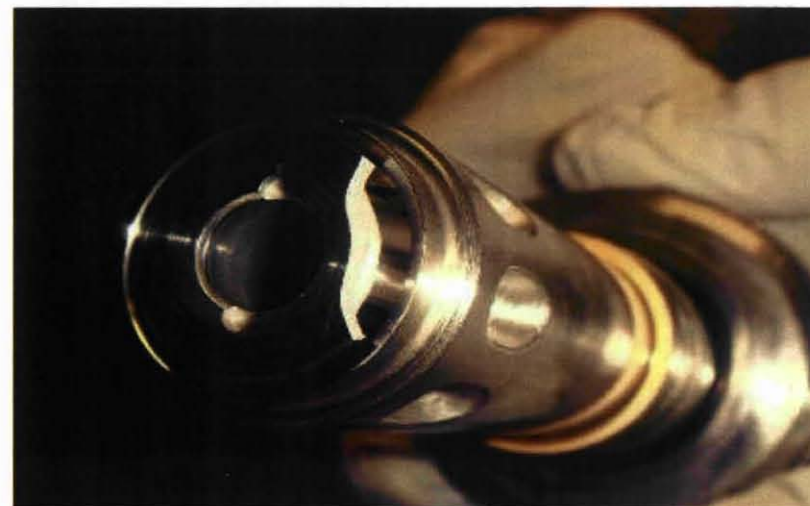
Valve Poppet Following Removal

- M&P investigations determined the poppet failed as a result of high cycle fatigue loading (to be covered in greater detail in following presentation)

- Most probable cause for the failure was identified as being GN2 ground test induced 'starter' cracks that gradually grew to failure over the course of the 11 flights of this valve

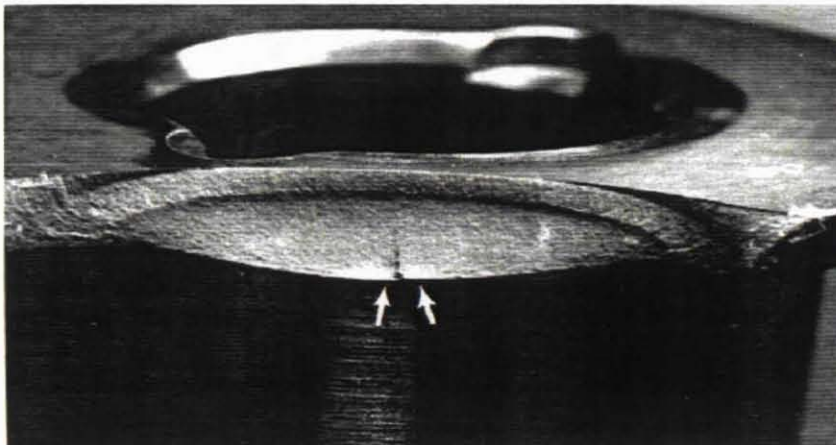
Fracture of 1st poppet (type -0361)

- In 1990, two poppet failures (from a shipset of new FCVs being manufactured for OV-105 build) occurred during acceptance testing in GH2 flow test
- M&P fractography of the two previous failures found indications that the failures initiated in fatigue but failed primarily by overload
 - Crack initiations indicated low stress/high cycle
 - Poppet break concluded to be induced by high stress
- Multiple changes were implemented

- Post 1990 poppet failures, -0361 FCV poppet drawing changes were incorporated
 - Eliminated 440C as an acceptable alternate material for poppet - only 440A was used from that point forward
 - Poppet heat treatment was altered & temper cycle added to reduce possibility of embrittlement
 - Recent investigation showed this change to be somewhat ambiguous (drawing not clear) and several heat treat processes were actually used in subsequent poppet builds
 - Non destructive examination NDE (dye penetrant) was added
- Following recent 2008 poppet failure, -1301 FCV poppet drawing updated with following changes
 - M&P community agreed upon heat treatment process
 - Drawing ambiguity eliminated
 - Polish/etch of critical radius area
 - Scanning Electron Microscope inspections added
 - Eddy current inspections added

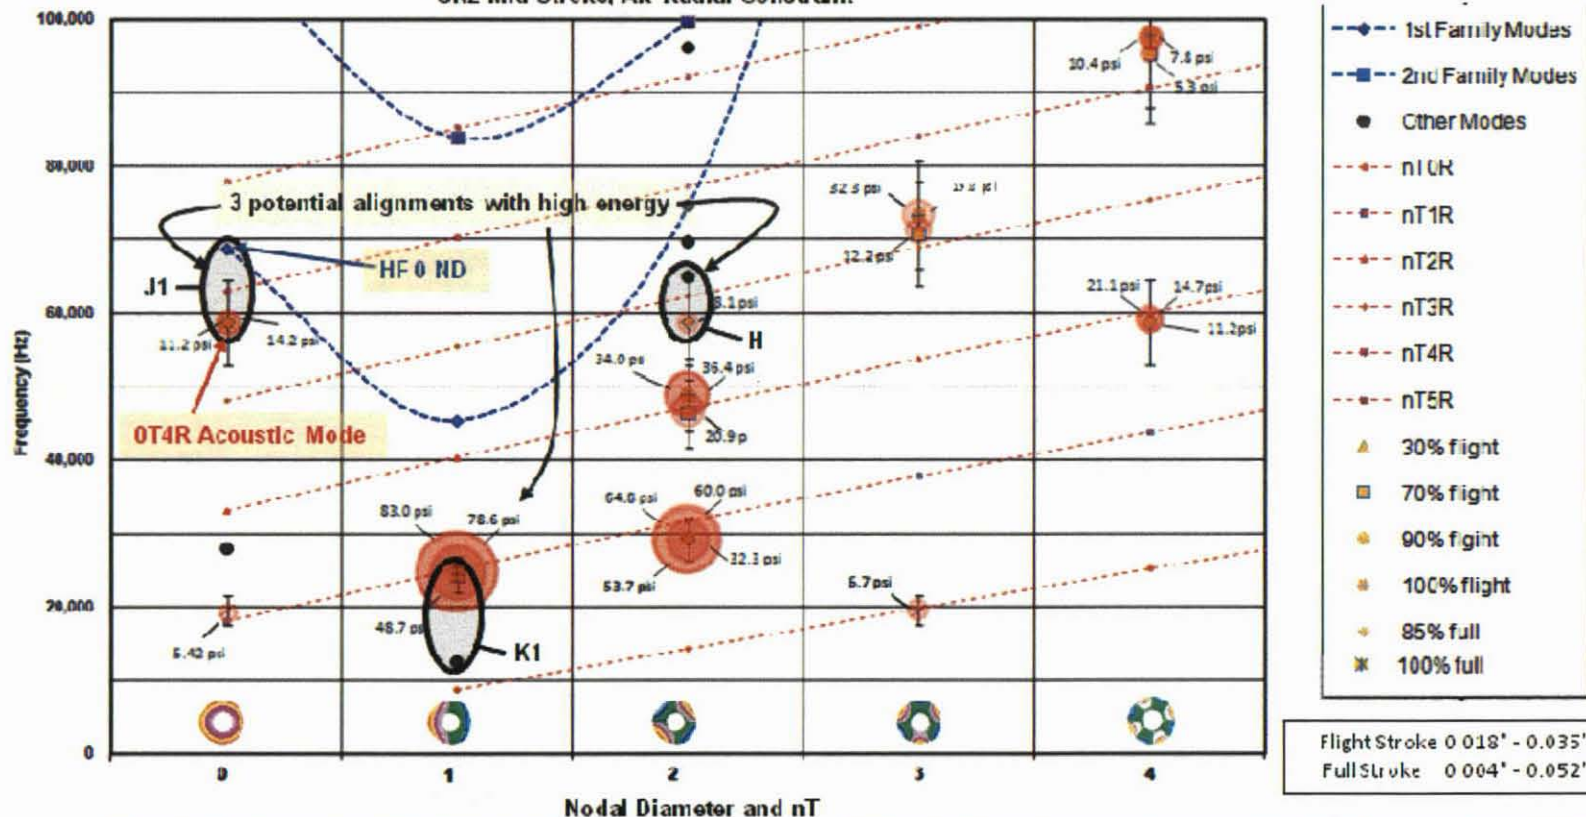
FCV Structural and Acoustic Modes (Overlaid)

Acoustic mode mean pressures are indicated by size of orange filled circles. GN2 pressures are generally higher than GH2.

Note: At 100% full stroke, the poppet seats and structural modes shift from the unseated condition. The 0-ND structural mode at 56 kHz shifted down from 69 kHz prior to seating, crossing through the 0T1R acoustic mode at 59 kHz.

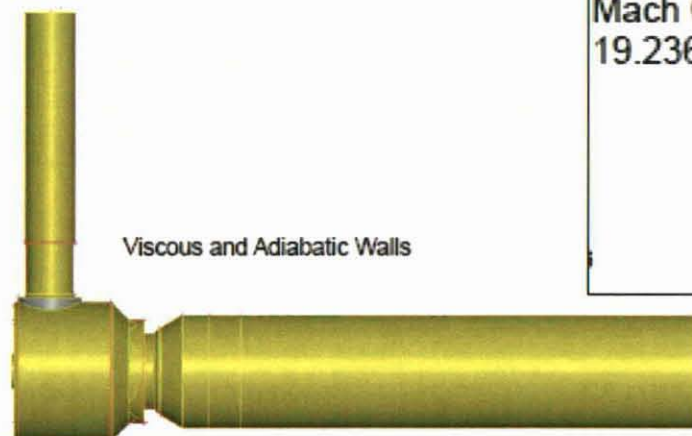
Mach Contour
Original Design

Well developed "Mach Cells", plume freely impinges on wall

Per CFD analysis, 19.2 degree diverging outlet tube reduces high velocity impingement on wall, minimizing energy transmitted to poppet face
Testing would be required to verify poppet flow balance can be achieved

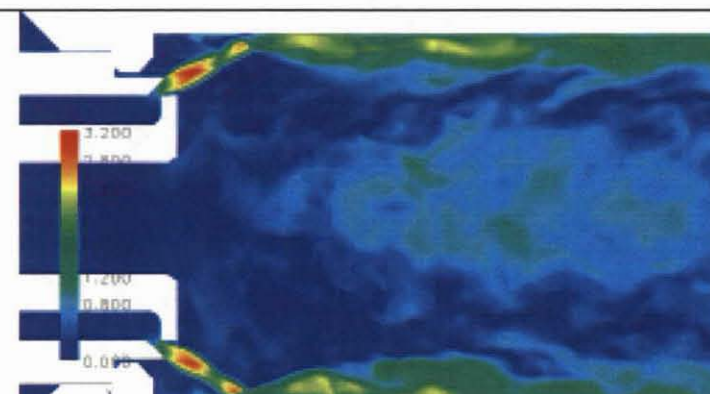
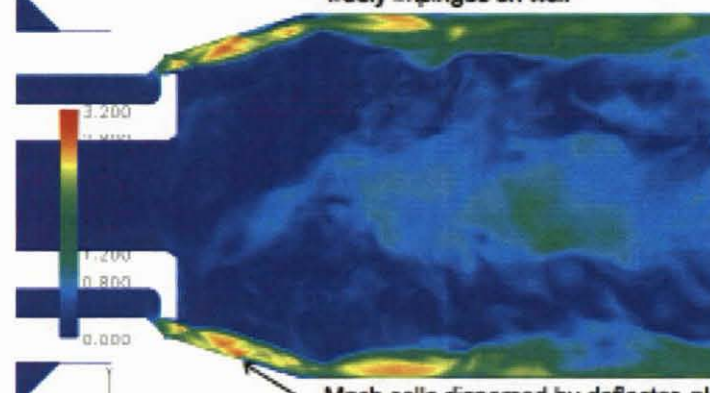
Mach Contour
19.236° Redesign

Mach cells dispersed by deflector, plume guided further downstream
